# Electrical safety

on board of luxury yachts and cruise liners

# Luxury should be safe too

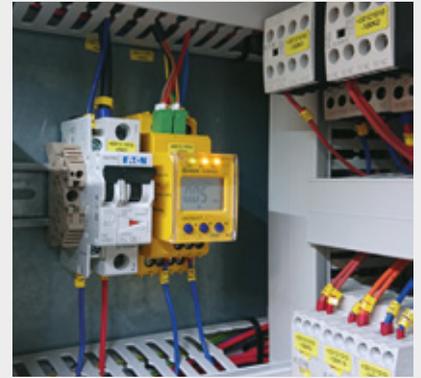
Residual current monitoring with the RCMA423 residual current monitor

He opted for residual current monitoring with the decentralised RCMA423. Other alternatives would be the bus-controlled central 12-channel residual current monitoring system LINETRAXX® RCMS460-D and the decentralised single-channel RCMB300 series.

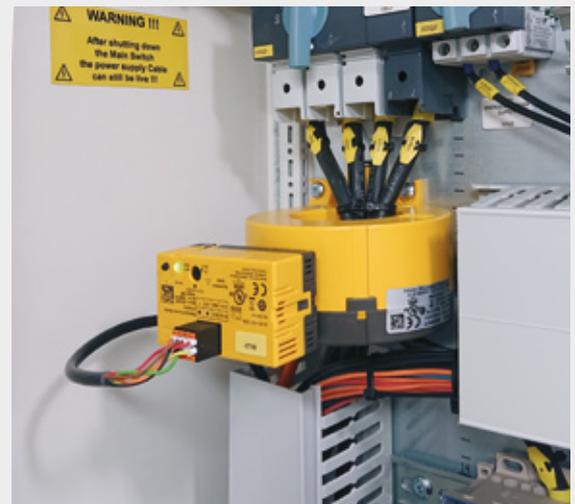
CTUB100 series measuring current transformer in the distribution units

The system uses the corresponding measuring current transformers to measure fault and leakage currents in the earthed power supply and evaluate them directly. This made it possible to quickly determine which sub-distributions were causing the detected residual current of a few amperes without having to limit the functionality of the guest and owner areas.

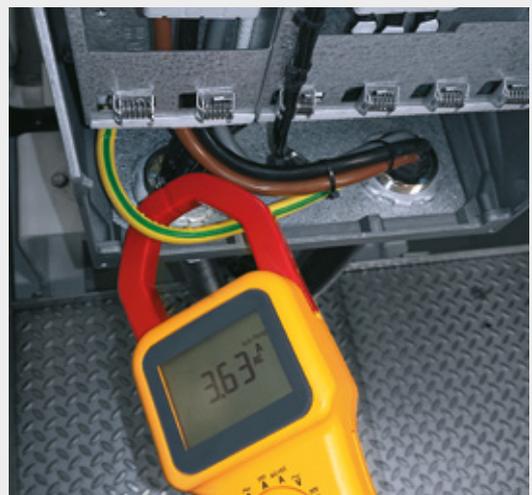
Stray currents detected

In the traditional systems of older ships, these additional earthing points would have had little effect. In modern ship installations, however, various connections with good conductivity have been added. The data cables, whose shields are made from copper braiding or aluminium foil, conduct the current but have a low current carrying capacity. This means, for instance, leakage currents with double-digit amperage have been measured over parallel data cables in data centres – a fire-hazardous situation in the truest sense of the word. In addition to the effect on data quality and bandwidth and the unplanned system crashes (blue screen), leakage currents can lead to charred cables and even fires.

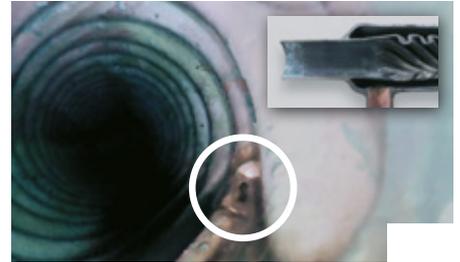
Fig. 1: Electrical spot corrosion at sea water cooled chiller condenser

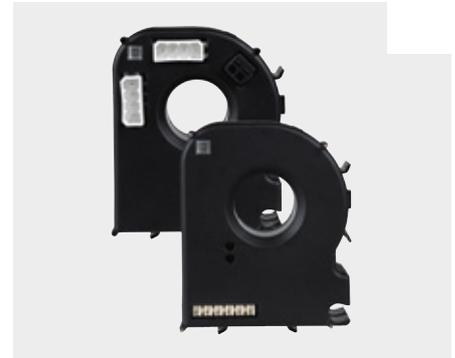
RCMB132 AC/DC

The RCMB132 AC/DC-sensitive residual current monitoring module product range enables the complete, continuous monitoring of each individual outgoing circuit. It has been tested in data centres and is also ideal for continual use in final circuits on board. This module can be refitted and local cabling laid on board during operation. It is installed on the circuit breakers in the sub-distribution and monitors the individual outgoing circuits. Evaluation takes place digitally via Modbus protocol, either to the next automatic sub-distribution or to a local operating panel. In addition to digital recording, LEDs are available to show the crew where a fault has occurred. Thanks to the comprehensive residual current monitoring on board, stray currents and incidents that endanger human life and installations can be avoided, even in complex systems.
